## TTT SED and Uglie Poles

Case Study CS001:Feb19 | ©TTT Products Ltd. | Page 1 of 2

# **Deep Piles & Retaining Walls**

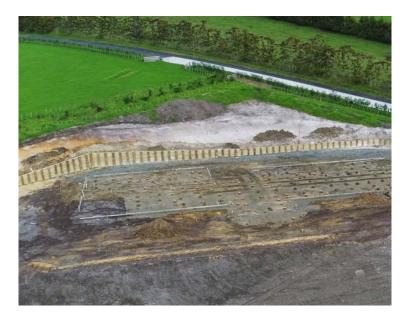
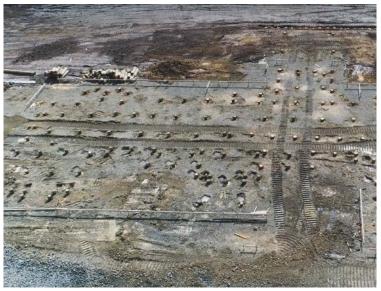
Photos courtesy of Markovina Pile Driving

- TTT supplied 4.8m x 300mm Uglie Poles for the in-ground retaining wall. This wall was required to create slope stability on the site. The Uglies were installed at 750mm centres, on the down hill side of the site at the toe of an identified slip circle.

- The contractor installed the poles using high frequency vibration.
