# **In-Ground Retaining Wall**

using TTT Poles

TTT Uglie Poles were used to construct a temporary In-Ground Retaining Wall at the foot of a bank below a major motorway offramp. The site was located in Takanini, Auckland.

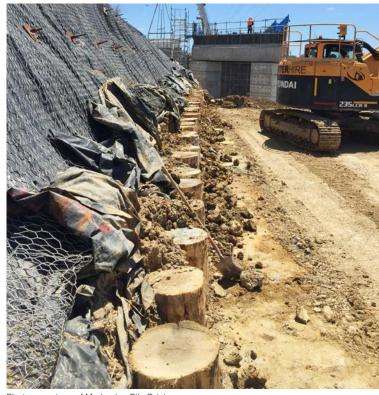
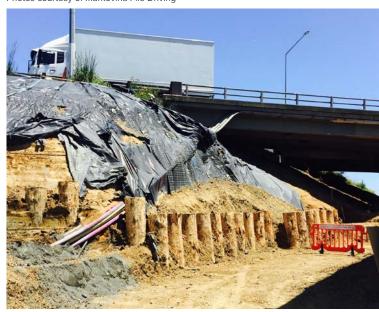
Photos courtesy of Markovina Pile Driving

- TTT Uglie Poles were ordered by the contractor.
   Due to the nature of the temporary works untreated poles were used.
- TTT Uglie Poles are similar to SED poles but are debarked rather than peeled. They offer greater skin friction when used as piles, and are stronger than SED poles.
- TTT supplied 85 pieces, 9.0m x 400mm Uglie Poles.
- The poles were installed with very close spacing.
  In order to achieve this the contractor installed every
  second pole for the length of the wall, then passed back
  to install the remaining poles. Installation was done this
  way so that densification was dispersed evenly between
  the poles allowing all the poles to be installed to the
  required depths.
- The contractor installed the poles using high frequency vibration. No concrete was used.
- · The project was completed within 3 days.
