Retaining Wall

using TTT Poles

TTT SED POLES

Case Study CS005:Mar19 | ©TTT Products Ltd. | Page 1 of 2

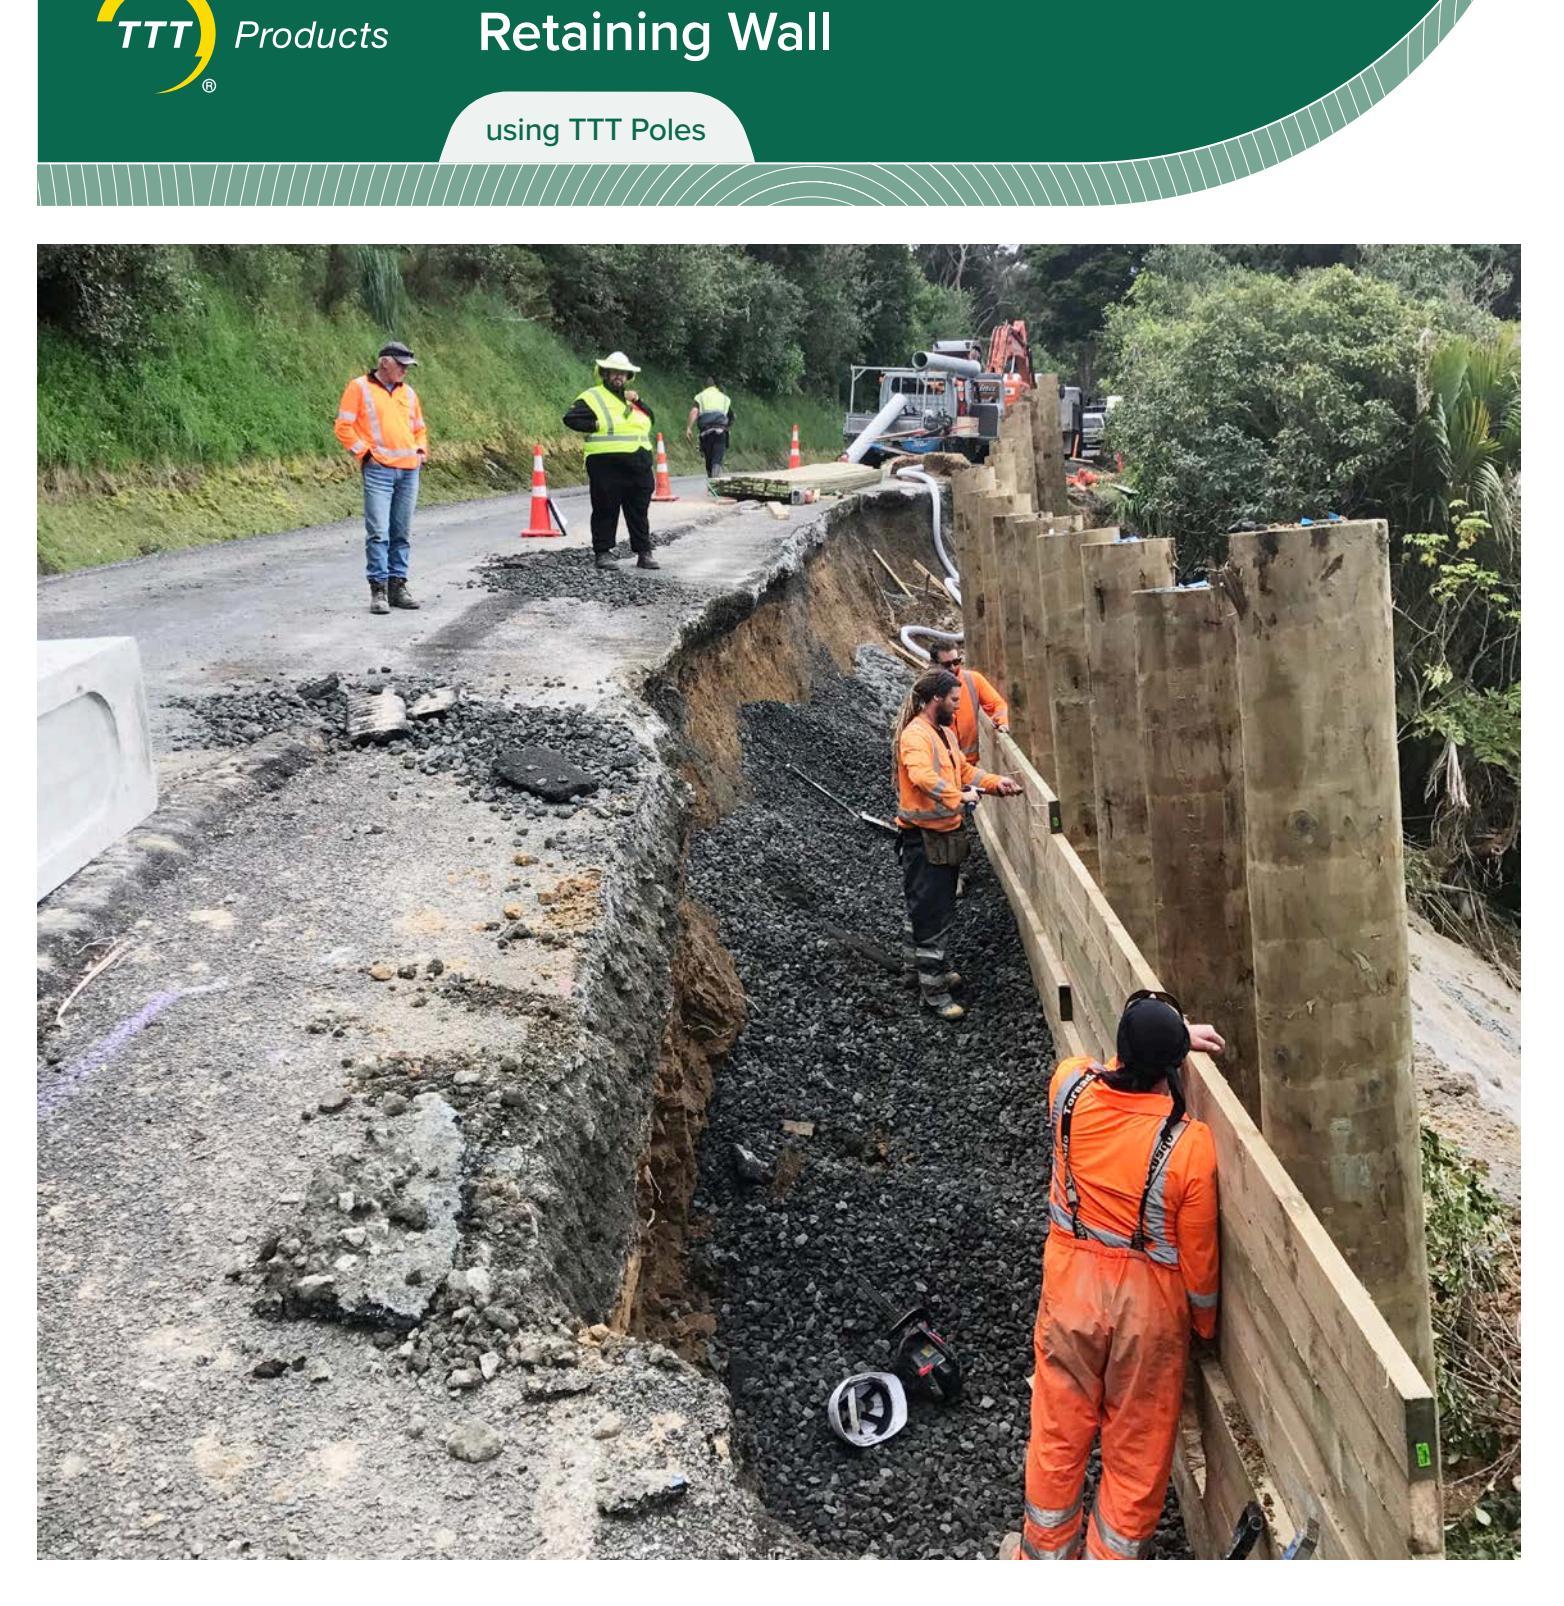
TTT SED Poles were installed as a retaining wall to stabilise a steep bank that had slipped causing one side of the road to disappear. The site was located in Kaukapakapa, Auckland.

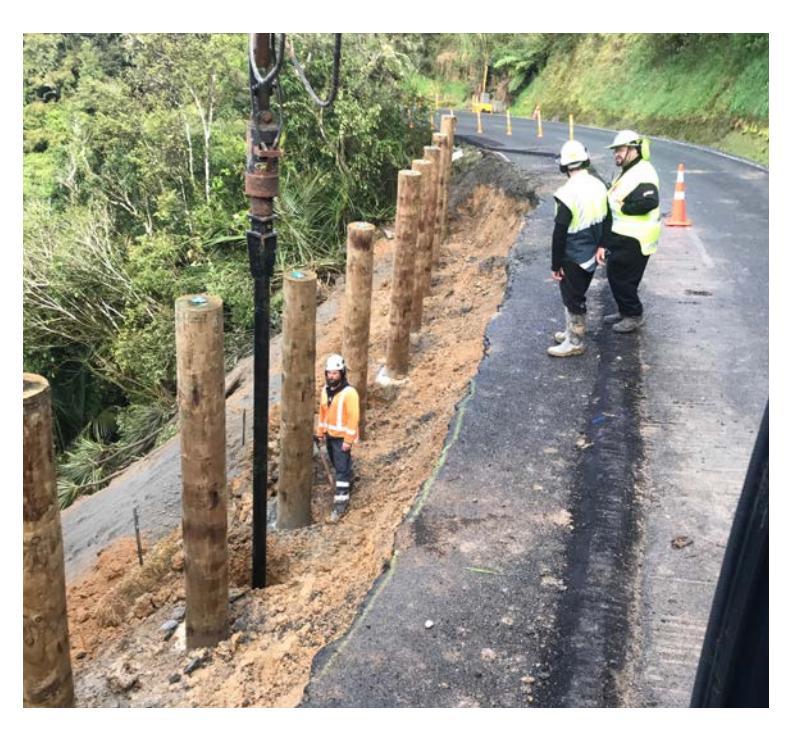
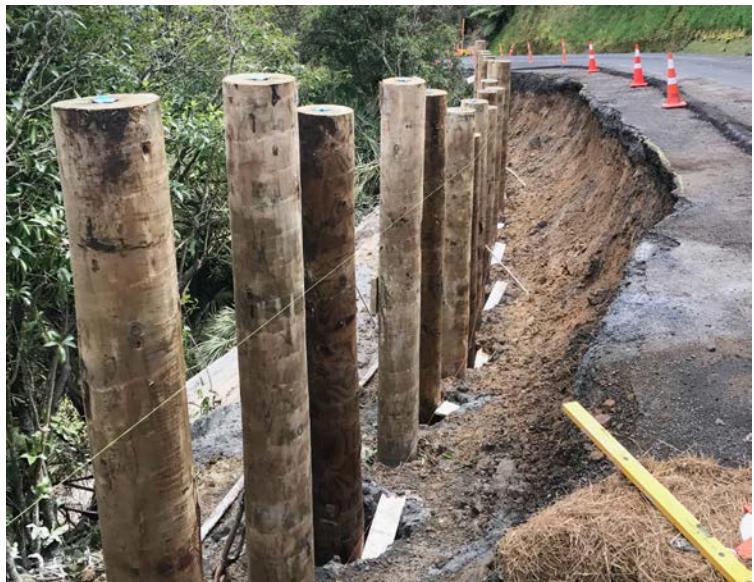
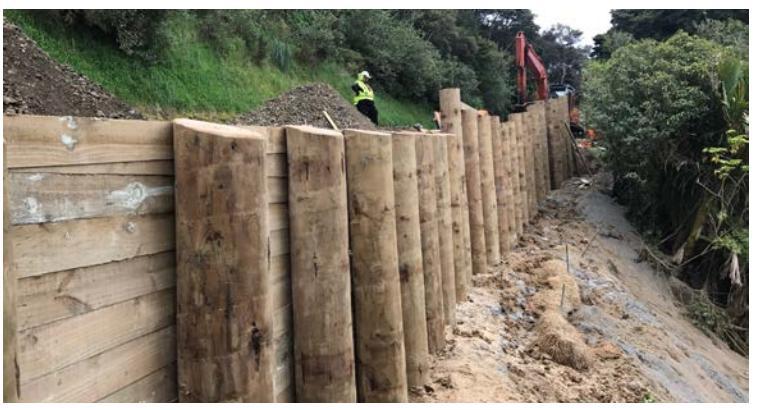
Photos courtesy of Markovina Pile Driving

- TTT SED Poles were ordered by the contractor.
- TTT SED Poles are naturally tapered, machine-peeled poles. Minimal wood is removed during processing so each pole retains its strength.
- TTT supplied 10.0m x 350mm SED Poles.
- The SED Poles were installed at 1.2m centres.
- The contractor installed the poles from the 'top-down' meaning the poles were installed from above the slip site. The retaining wall was then completed and the road reinstated.
- The contractor installed the poles by first drilling holes, then concreting the poles into place.
- The 3.5m high retaining wall was completed in one week.
